# Storm Induced Beach Profile Changes along the Coast of Treasure Island, West-Central Florida, U.S.A.

A thesis submitted in partial fulfillment  
of the requirements for the degree of  
Master of Science  
School of Geosciences  
College of Arts and Sciences  
University of South Florida

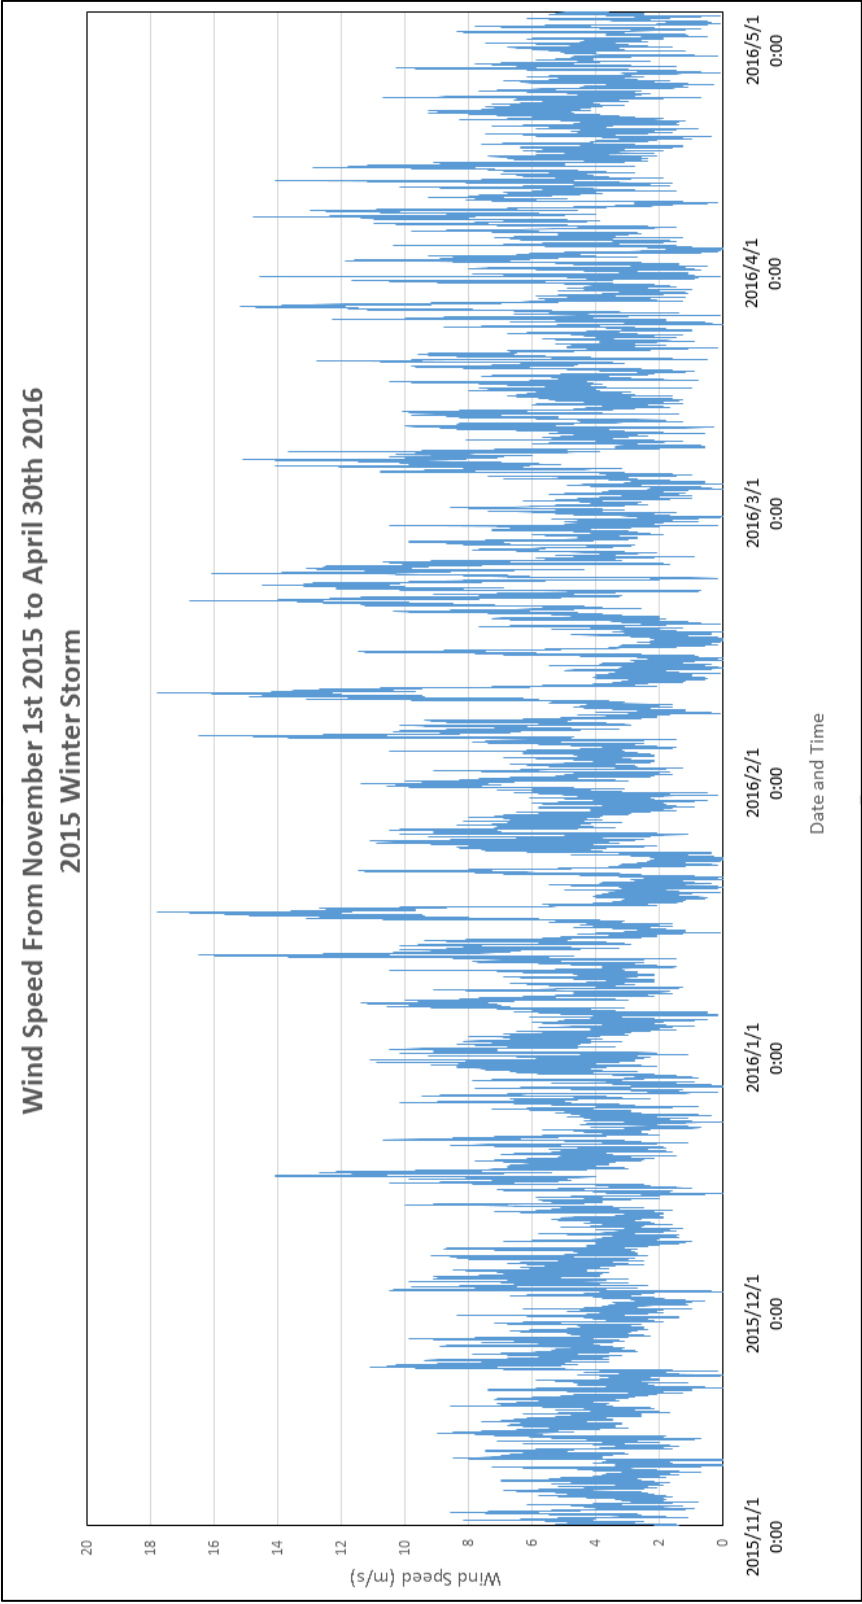
**Figure 51.** Wind speed changes during the winter of 2015, November 1<sup>st</sup> 2015 to April 30<sup>th</sup> 2016.

In the winter 2015, wind conditions were wilder than the winter of 2014 (Figure 51). Most of the time, wind speeds remained below 12 m/s. Only during a couple of days wind speeds reached more than 14 m/s. However, waves generated by the wind were higher than the waves in winter 2014 (Figure 52). Wave heights during this period of time remained mostly below 3 m. In comparison, wave height in year 2016 reached 4.77 m and 6.41 m respectively. In early and late February 2016, wave height achieved 5.68 m and 5.04 m respectively as another two peaks as shown in Figure 52. Meanwhile, at these times wind speeds also increased to the highest values of 17.9 m/s and 16.8 m/s as shown in Figure 51. The peak wave height during the winter was 6.41 m and the mean wave height was 1.26 m.

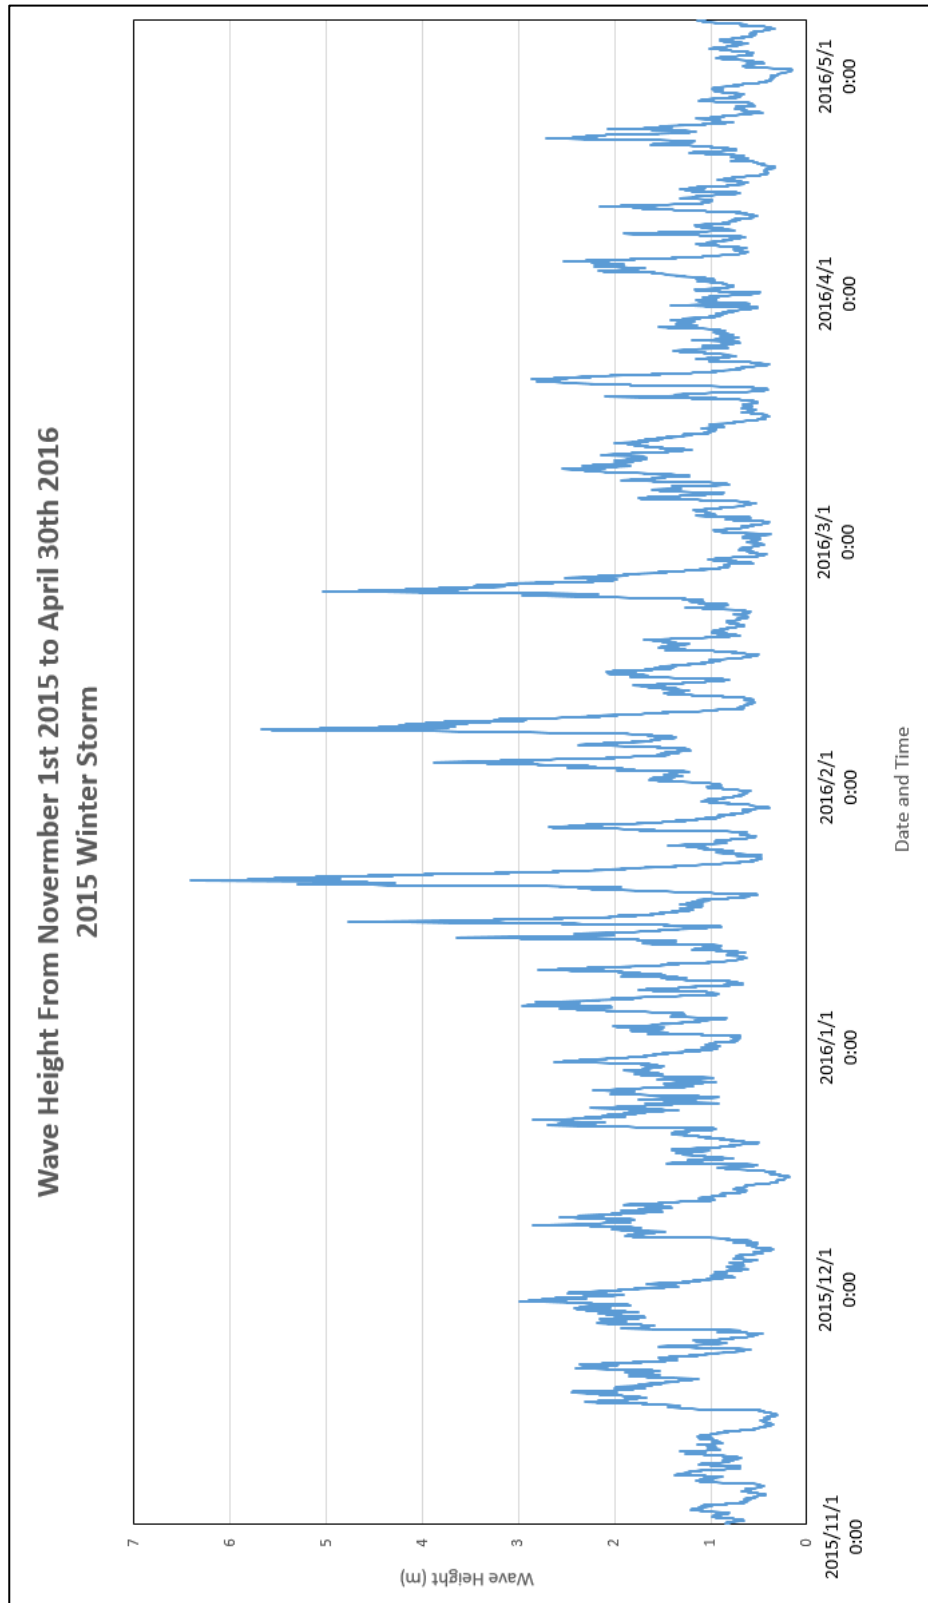
**Figure 52.** Wave height changes during the winter of 2015, November 1<sup>st</sup> 2015 to April 30<sup>th</sup> 2016.

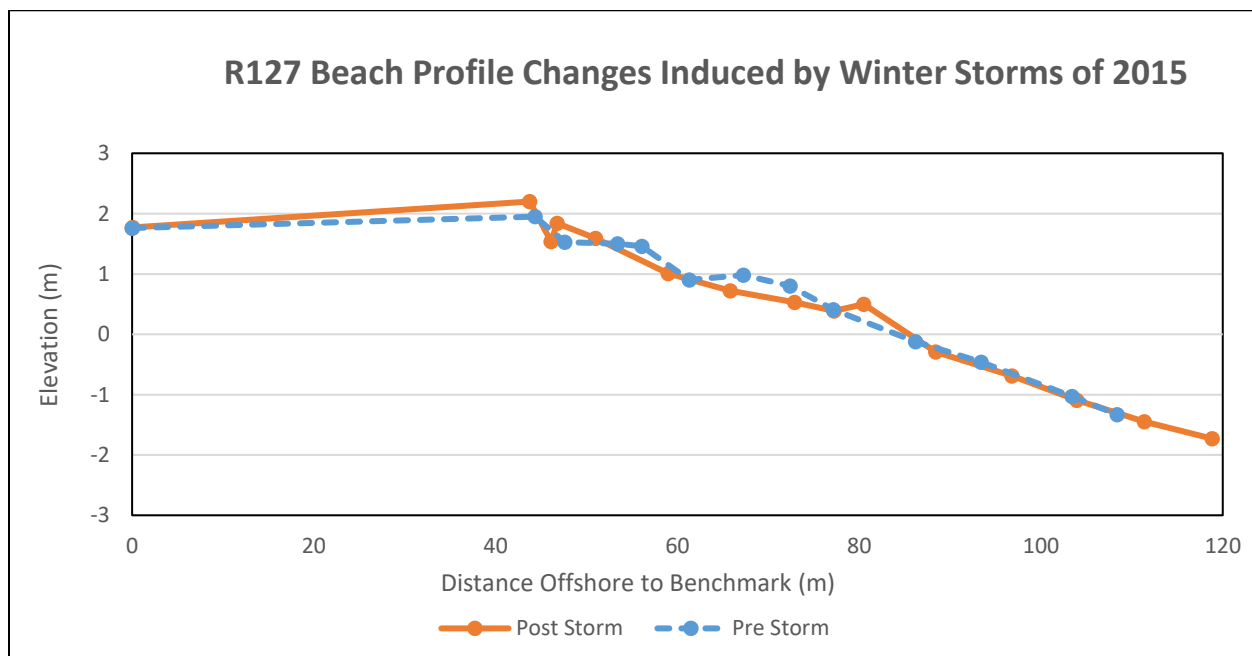
**Figure 53.** Beach profile changes at survey line R127 due to winter storms of 2015.

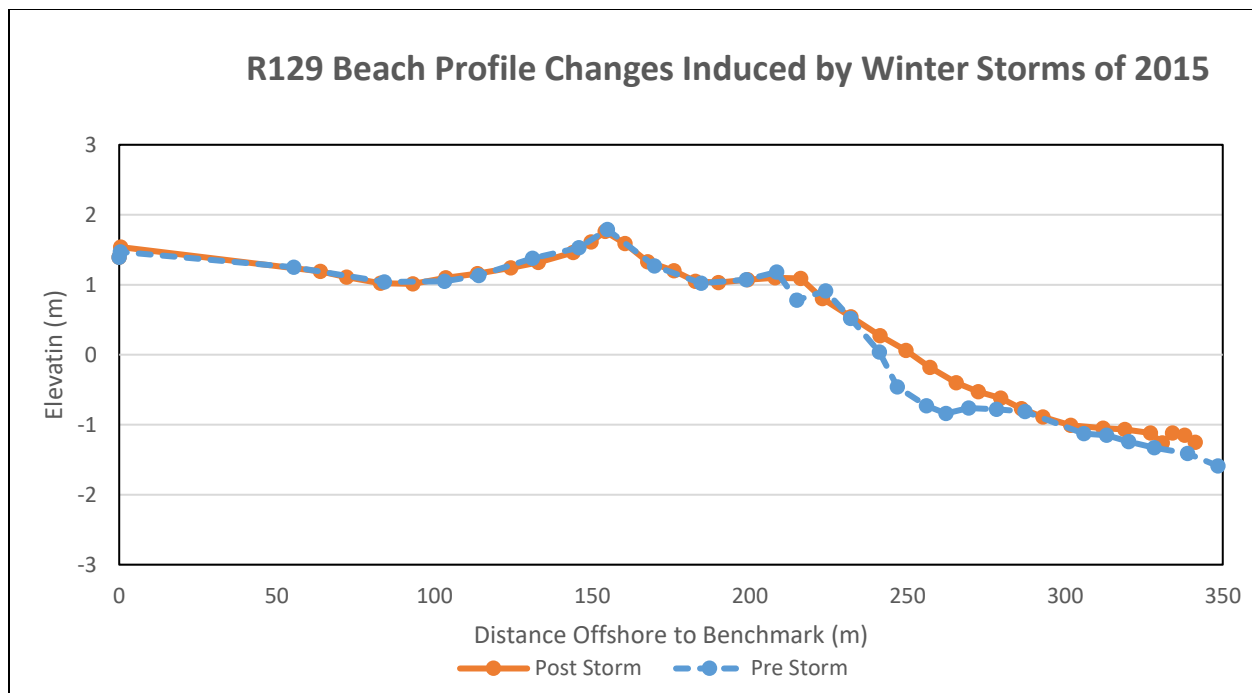
**Figure 54.** Beach profile changes at survey line R129 due to winter storms of 2015.

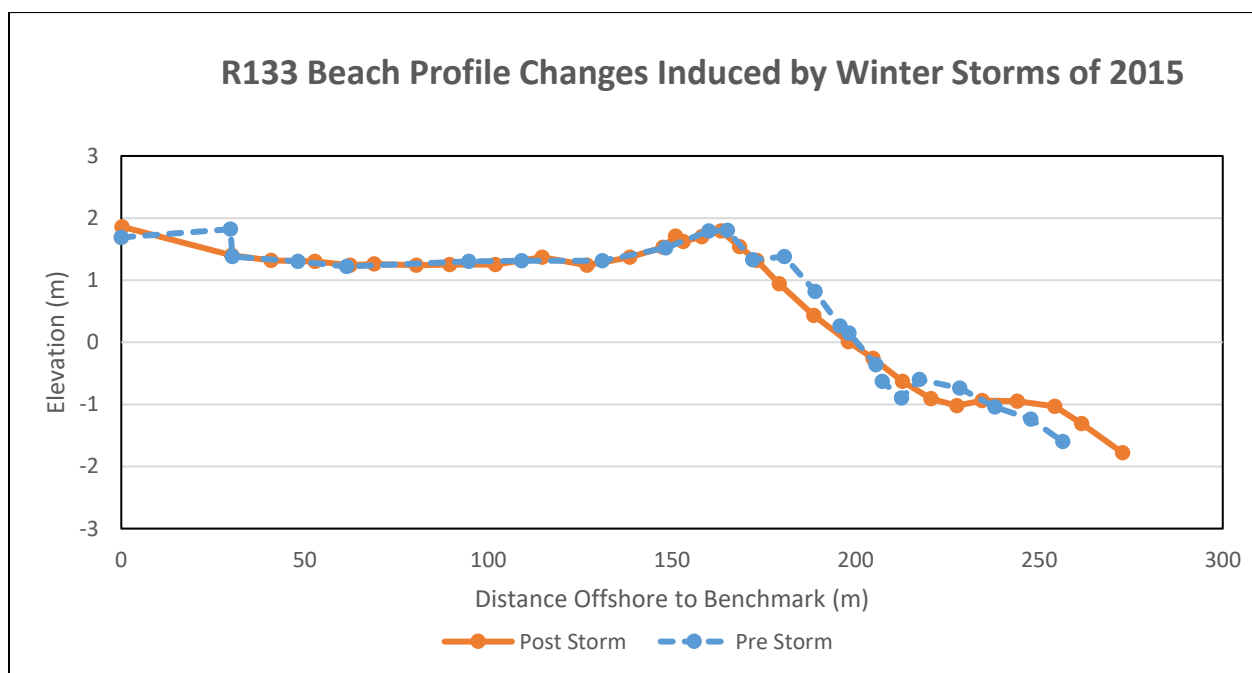
**Figure 55.** Beach profile changes at survey line R133 due to winter storms of 2015.

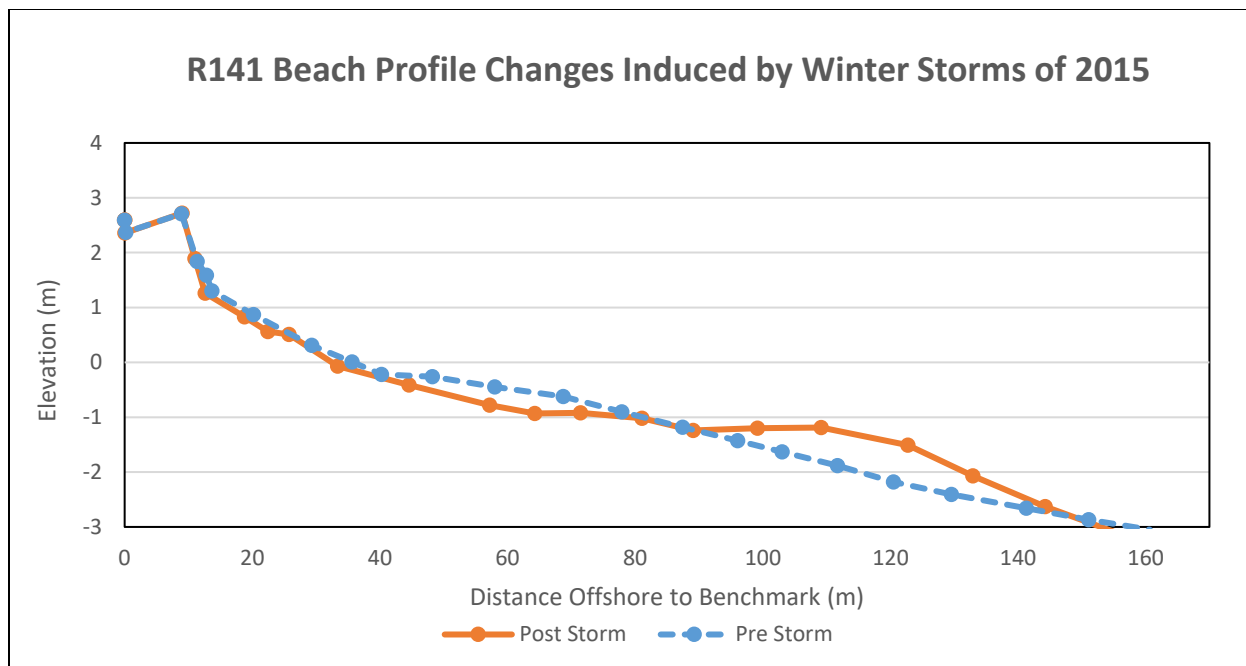
**Figure 56.** Beach profile changes at survey line R141 due to winter storms of 2015.

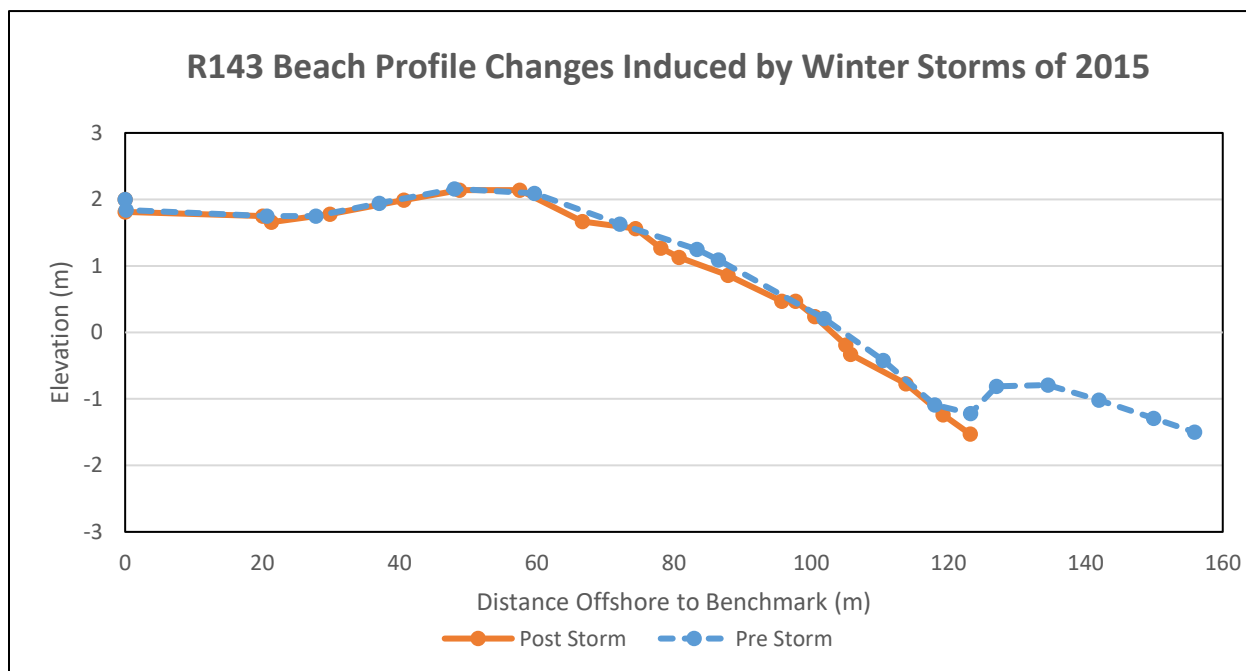
**Figure 57.** Beach profile changes at survey line R143 due to winter storms of 2015.
